# Building on the Past

By Michael Miyamoto, LC/DBM

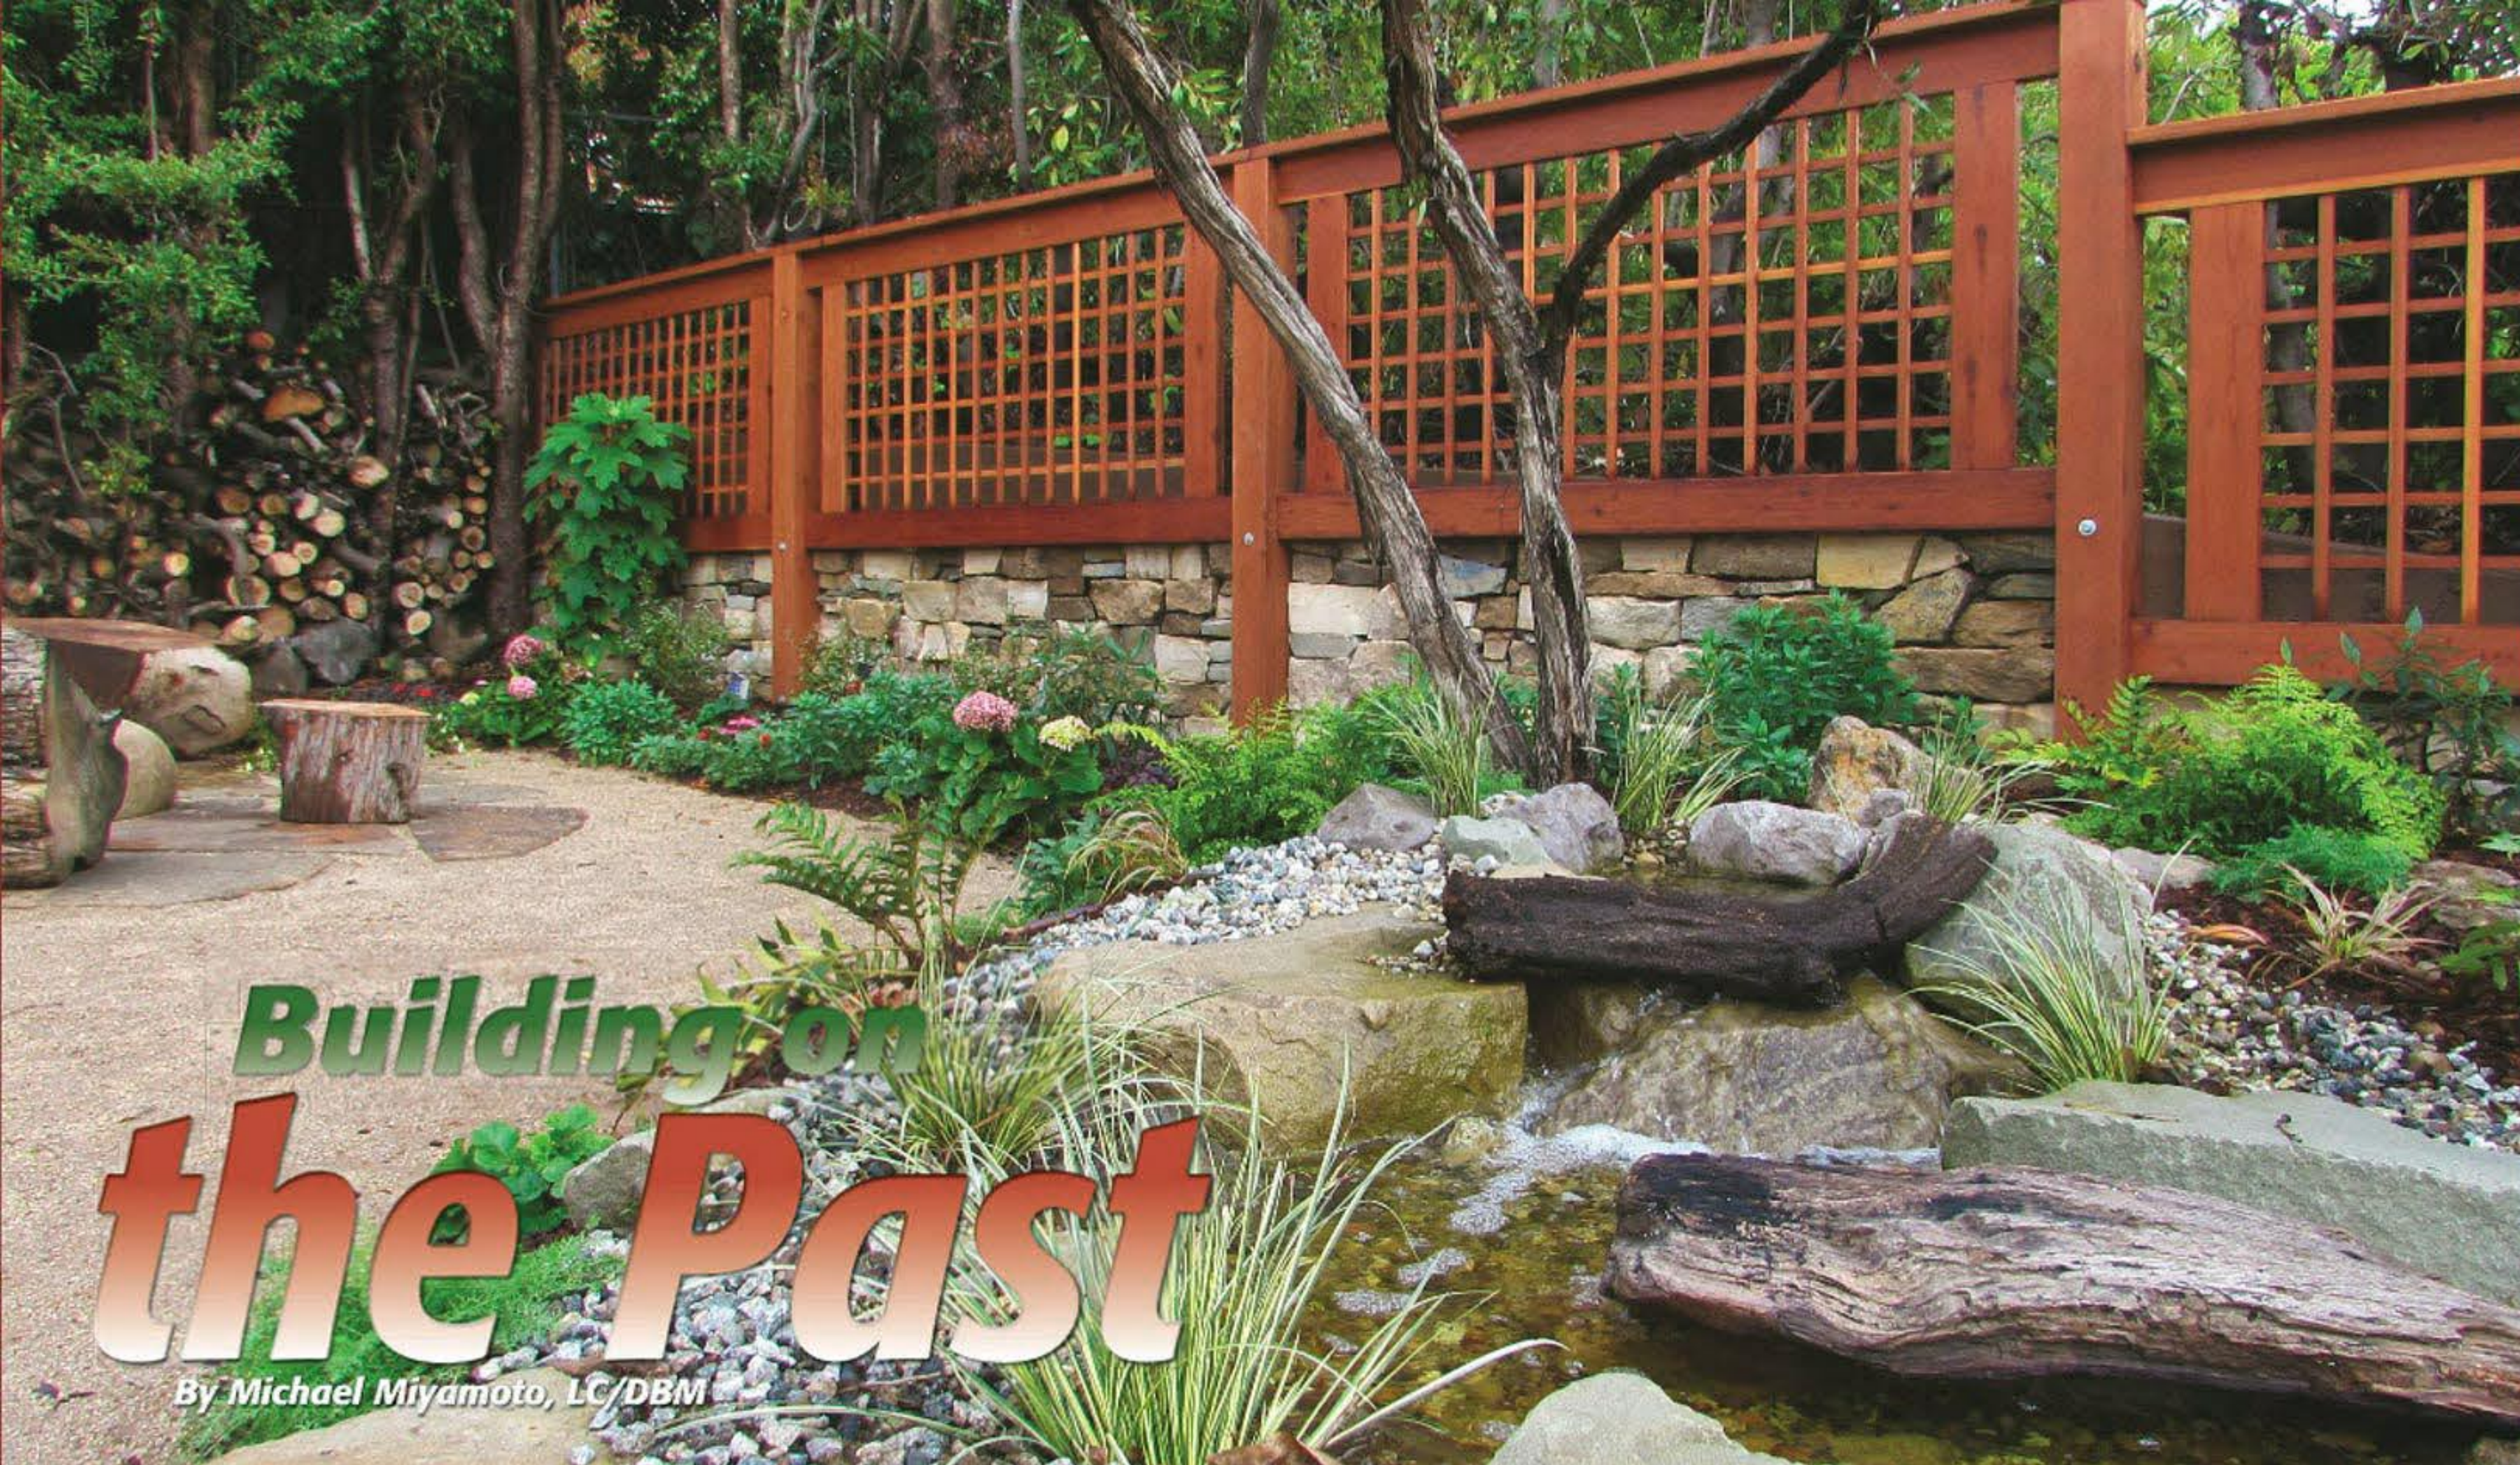
**Above:** The backyard of this Los Angeles home was redesigned and given a major facelift. Debbie Glikzman, owner of Urban Oasis Landscape, also of Los Angeles, used the existing retaining walls, but had them straightened, repaired and reinforced. Then her workers laid stone blocks along the face and on top of each wall by hand. A new redwood fence was installed along the top of the new stonewall. The project also included a natural water feature on one level, flowing to a tiny pond on a lower level. Giant boulders frame a fire pit, and small and large logs were added to this feature for seating. There are also raised planter beds, flagstone and brick pavers, and lighting and irrigation systems.

Although the existing retaining walls were sturdy, they were cracked and unsightly. Glikzman had her work crew fortify the walls with rebar and concrete, and then laid individual stone slabs by hand over the existing block. This gives the appearance of a dry-stacked stonewall.

Asked whether she encountered any challenges on this job, she said: "The existing retaining walls were crooked and needed to be stabilized. We reinforced them with rebar and filled the hollow spaces with concrete. Getting the stone facing to look like a natural stone wall instead of a veneer took a lot of finessing."

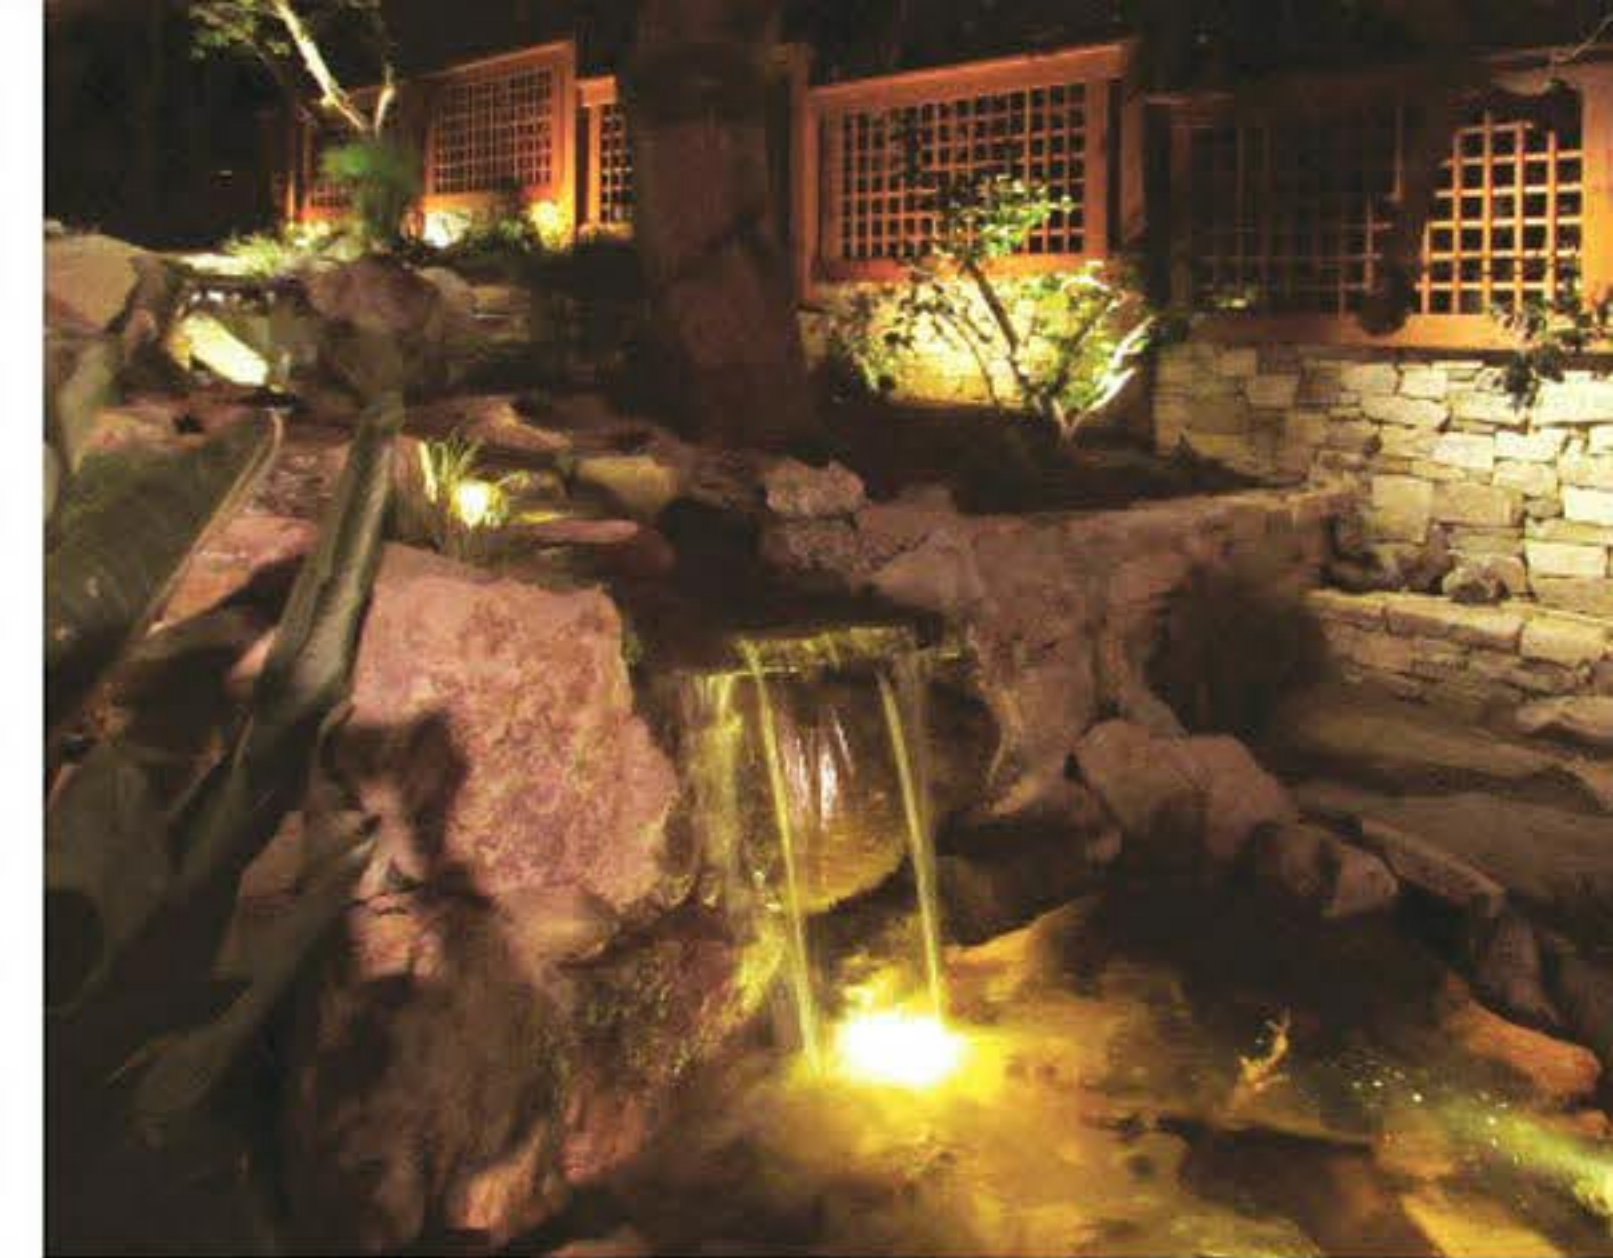
**Top, Right:** Pacific Outdoor Living installed the water feature and submersible LEDs. Water starts flowing from the water feature on an upper level and cascades down to a tiny pond on a lower level. FX Luminarie manufactured the landscape lights, and Del Rey Electrical installed the lighting system. A total of 41 landscape and submersible lights are in this project.

"A natural water feature starts at the top level and meanders down to a pond below," she adds. "Giant boulders frame a fire pit and small and large logs are used for seating."

Pacific Outdoor Living built the water feature; David Lightfoot installed the irrigation system; Del Rey Electric put in the lighting; and Israel Inequz installed all the plants.

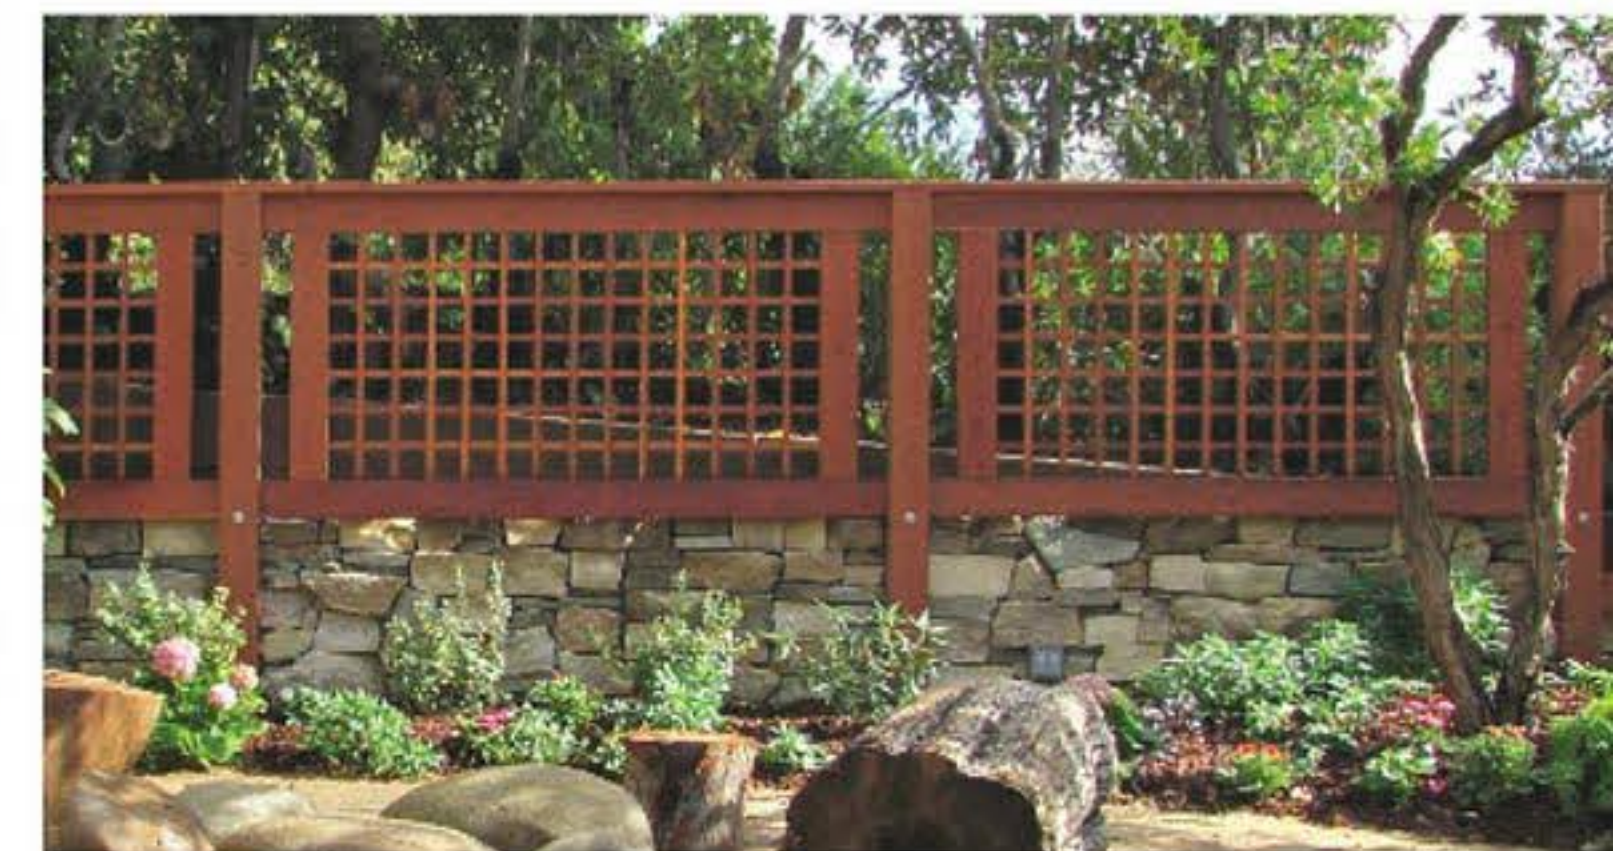
**Middle, Right:** The fence was custom built by one of Glikzman's subcontractors. It is made entirely of redwood, and the screens are basically trellises. The posts are 6" x 6" and the trellises are 1" x 1/2". The railings are 2" x 4". The fence was placed atop the existing retaining wall. "Getting the stone facing to look like a natural stonewall instead of a veneer took a lot of finessing," Glikzman said.

Francisco Sierra was the contractor for the job, and one of his friends, Victor Vasquez, was the carpenter who put together the wooden fence. The fence was built with redwood, and the screens for it are custom trellises that Vasquez also made

out of redwood. The posts are 6" x 6" and the trellises are 1" x 1/2".

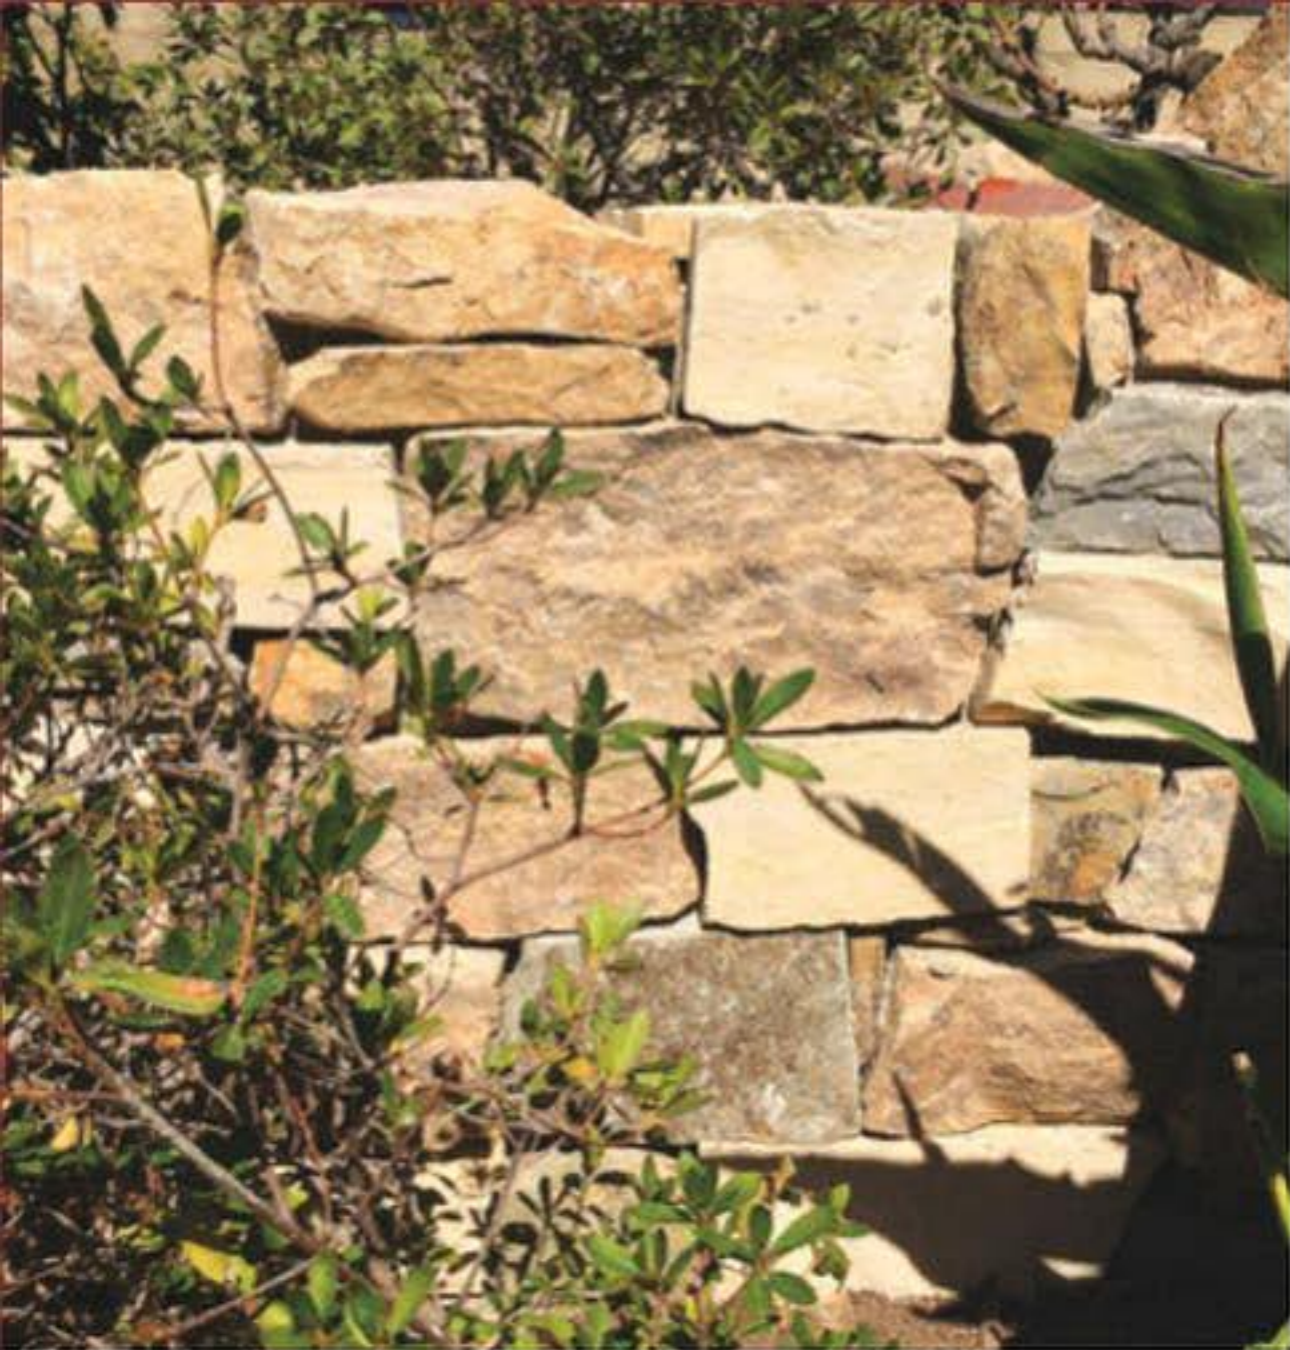
**Top, Left:** Although the existing retaining walls were sturdy, they were cracked and unsightly. Glikzman had her work crew fortify the walls with rebar and concrete, and then laid stone by hand on the facing side of the existing wall, as well as its top. This gave the appearance that this feature is dry-stacked. Each piece was mortared in place, but not grouted. No footing was required for this fence job, because the existing retaining wall has one already in place. The stone used for the walls was a combination of Monterey Cream, Deer Creek and McGregor Lake ledgestone and Yosemite Quartzite — all from a local supplier, Bourget Brothers. The company also sized each stone piece to Glikzman's specifications.

The stone used for the walls was a combination of Monterey Cream, Deer Creek and McGregor Lake ledgestone and Yosemite Quartzite — all from a local supplier, Bourget Brothers. The company also sized each stone piece to the builders' specifications. Sweetwater flagstone and brick were used as paving materials.

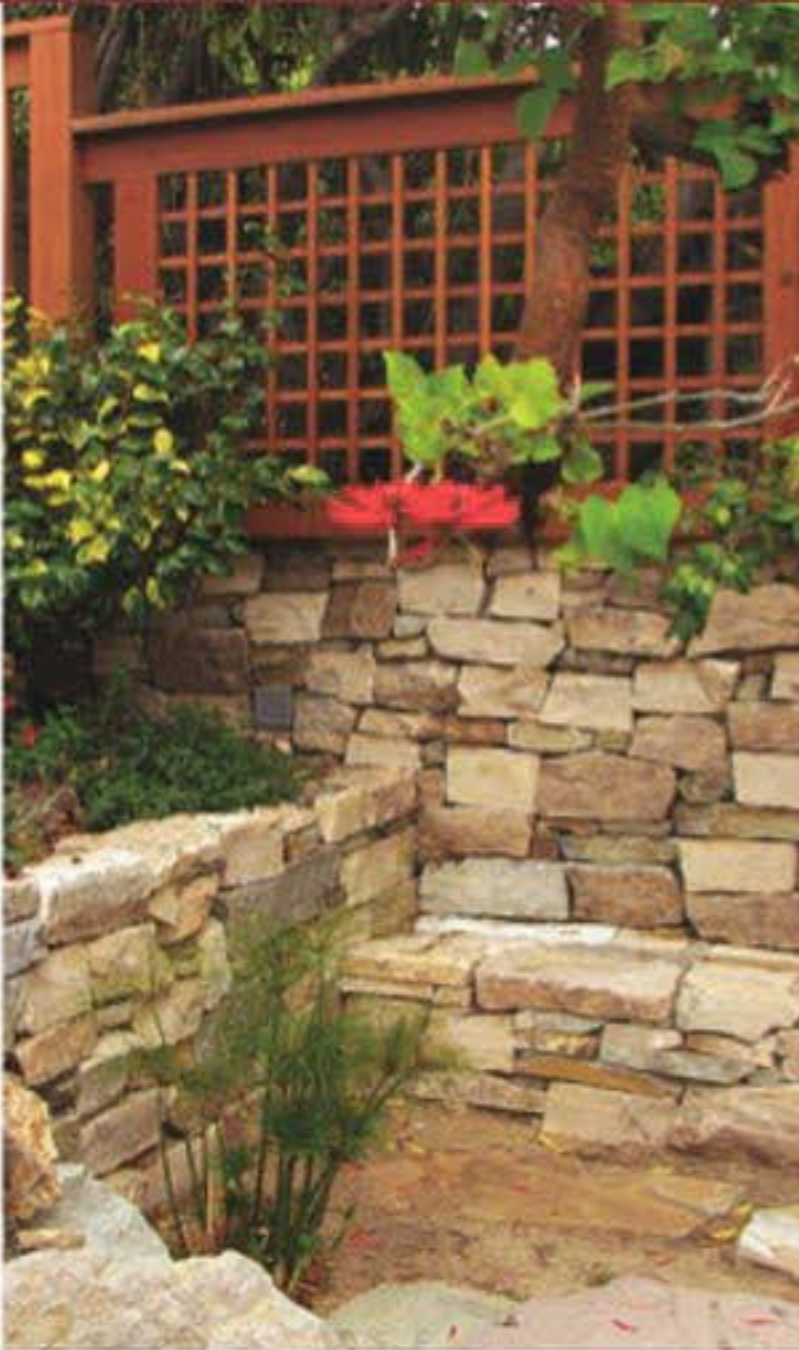
**Top, Right:** The 6" x 6" posts are buried in the ground and bolted to the existing wall, which already has a footing. So the fence is well supported by the wall, Glikzman said.

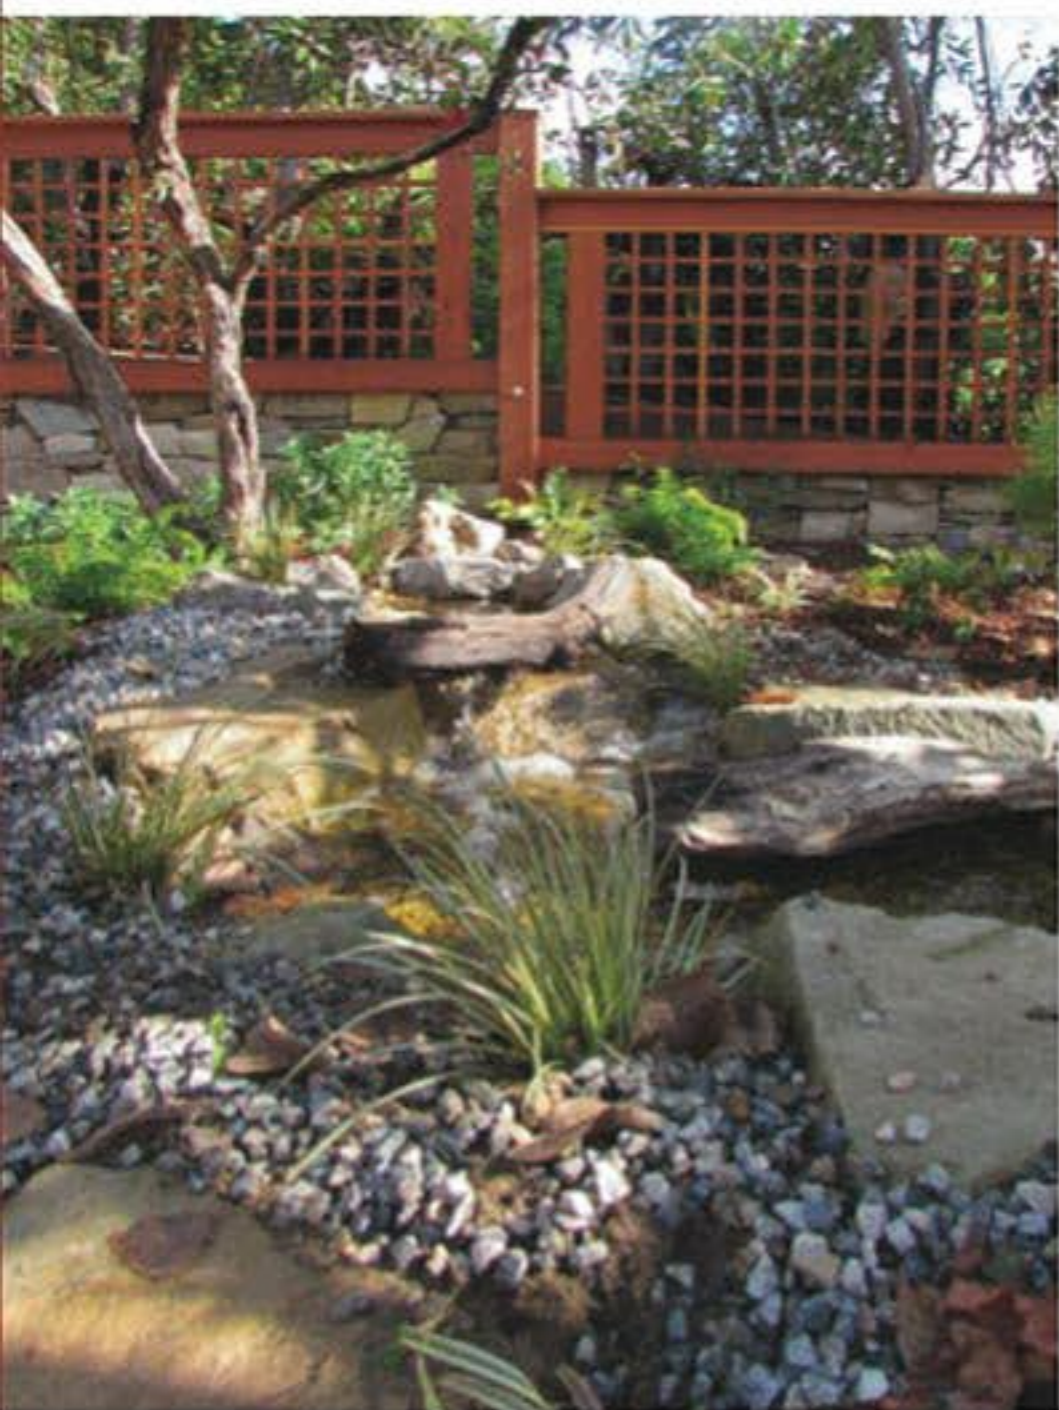
**Bottom, Left:** Generic boulders, river rocks, gravel and pebbles were used for the bed of the manmade stream.

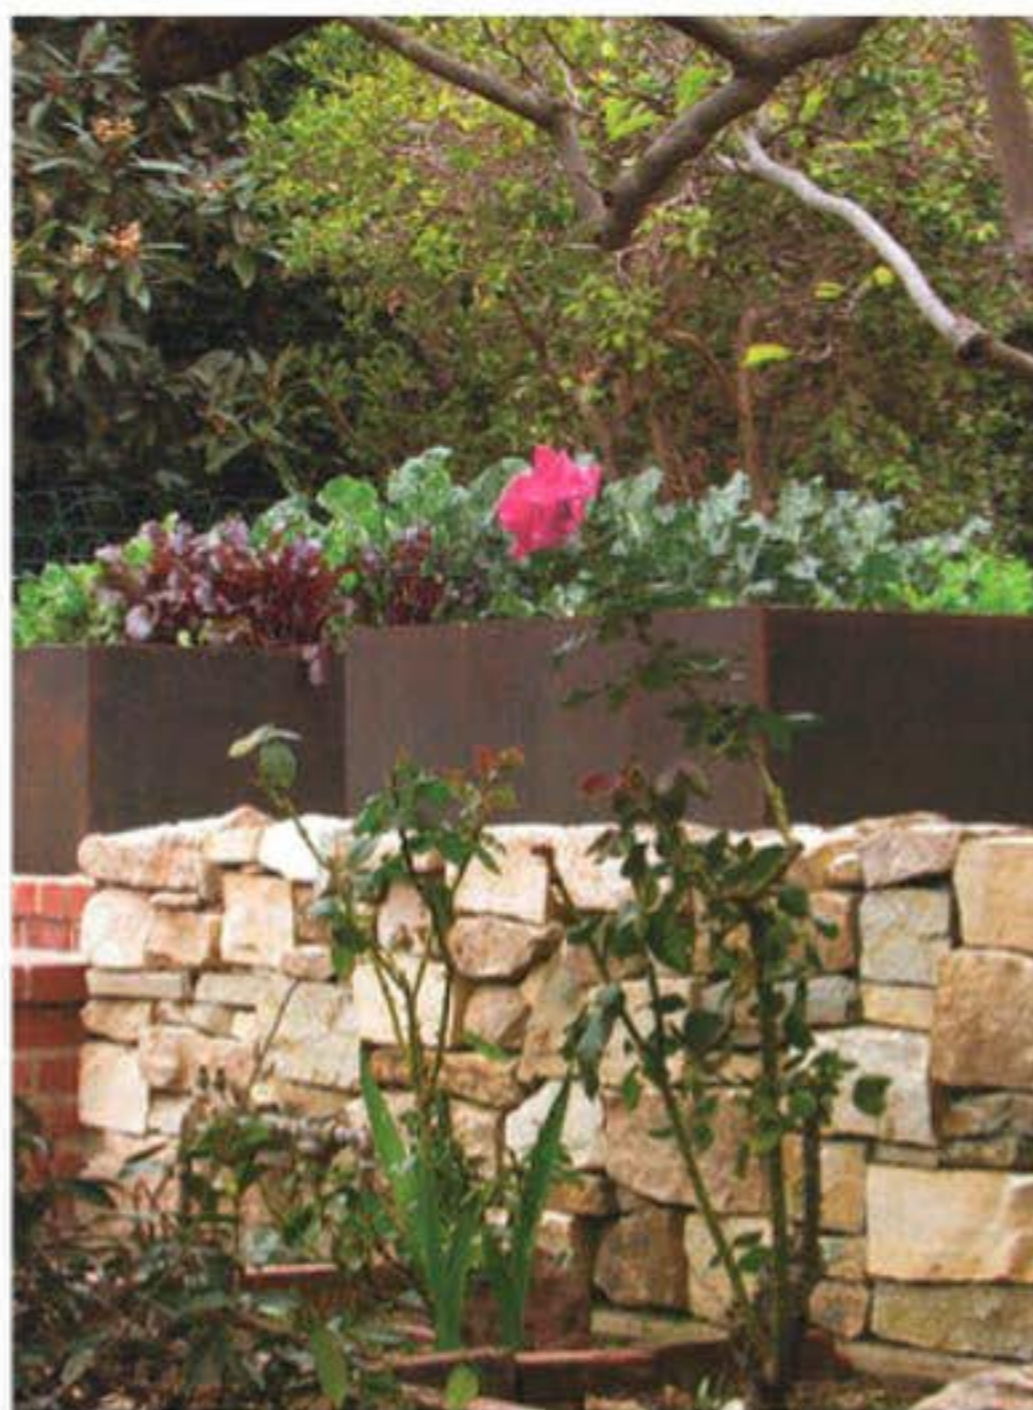
**Bottom, Right:** Sheets of COR-TEN steel, fabricated by Jaime Gracia of Gracia Designs, were used to create raised planter beds. Francisco Sierra, a subcontractor, installed flagstone and brick paving materials, repaired and reinforced the existing retaining wall and handcrafted the new stonewall.

Glikzman also included five enormous raised planter beds enclosed with COR-TEN steel in the project, all of them to grow vegetables because her client is an avid vegetable gardener. The client's backyard also has many fruit trees, berry plants and grape vines, so it's a virtual "food grower's heaven," Glikzman said. Jaime Gracia, of Gracia Designs, fabricated the COR-TEN material for the raised planter boxes.

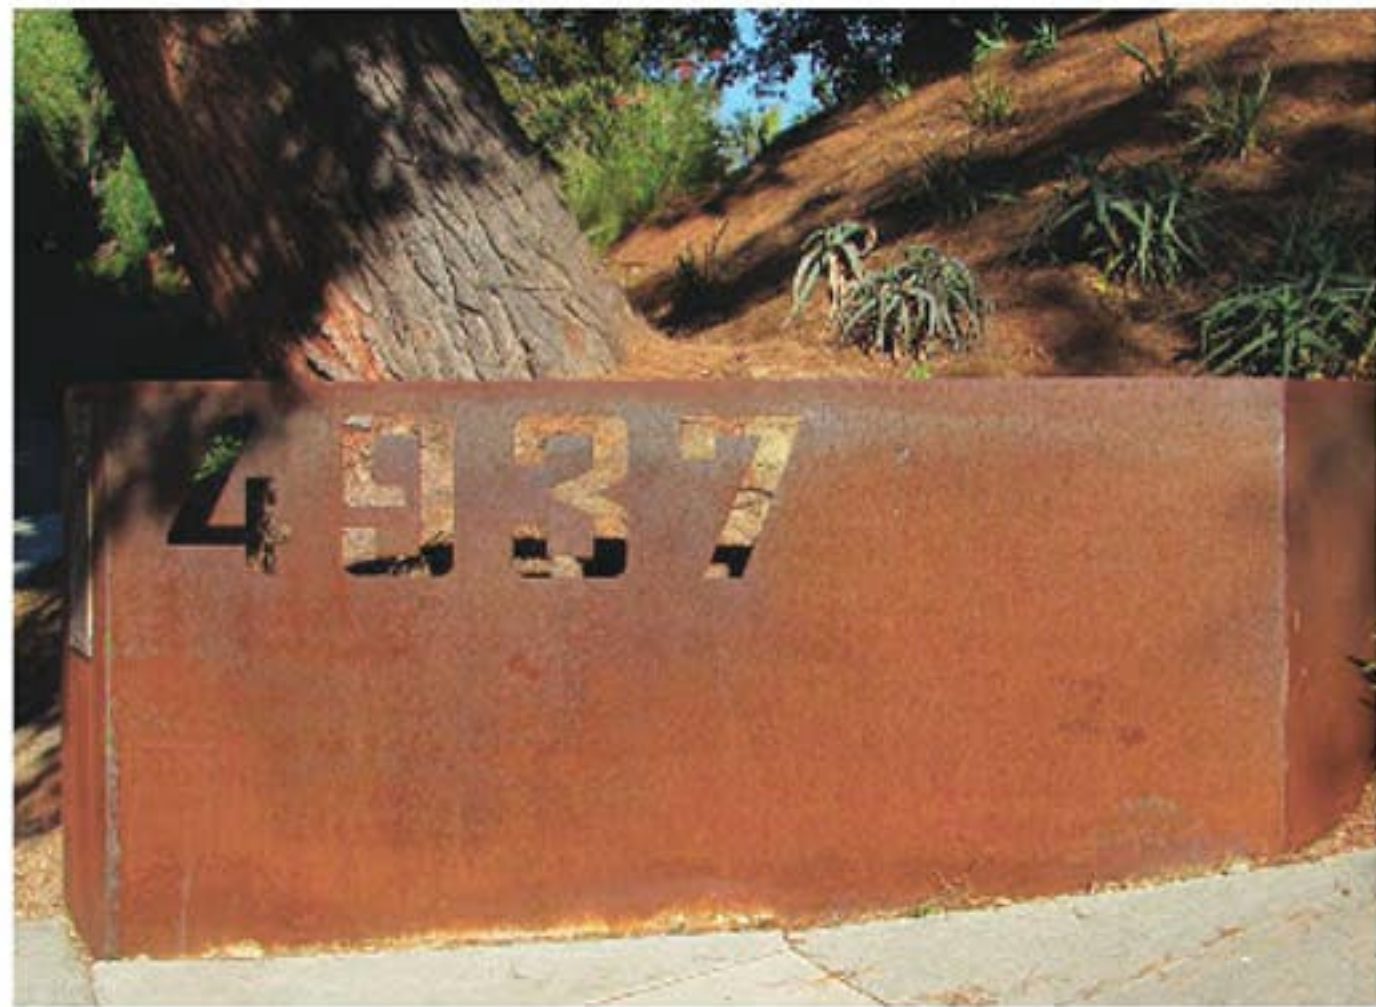
Debbie Gliksman of Urban Oasis Landscape, designed and supervised the installation of a fence, drought tolerant garden, deck, steps and more at this home in Tarzana, Calif. The job also included a decorative screen that was installed against an empty slope too steep to plant. The screen is made of COR-TEN, or weathered steel, which has a naturally oxidized finish that forms a stable rust-like appearance. Jamie Gracia, of Gracia Design, fabricated the screen, and also cut out the house address numbers, creating a graphic visual statement.

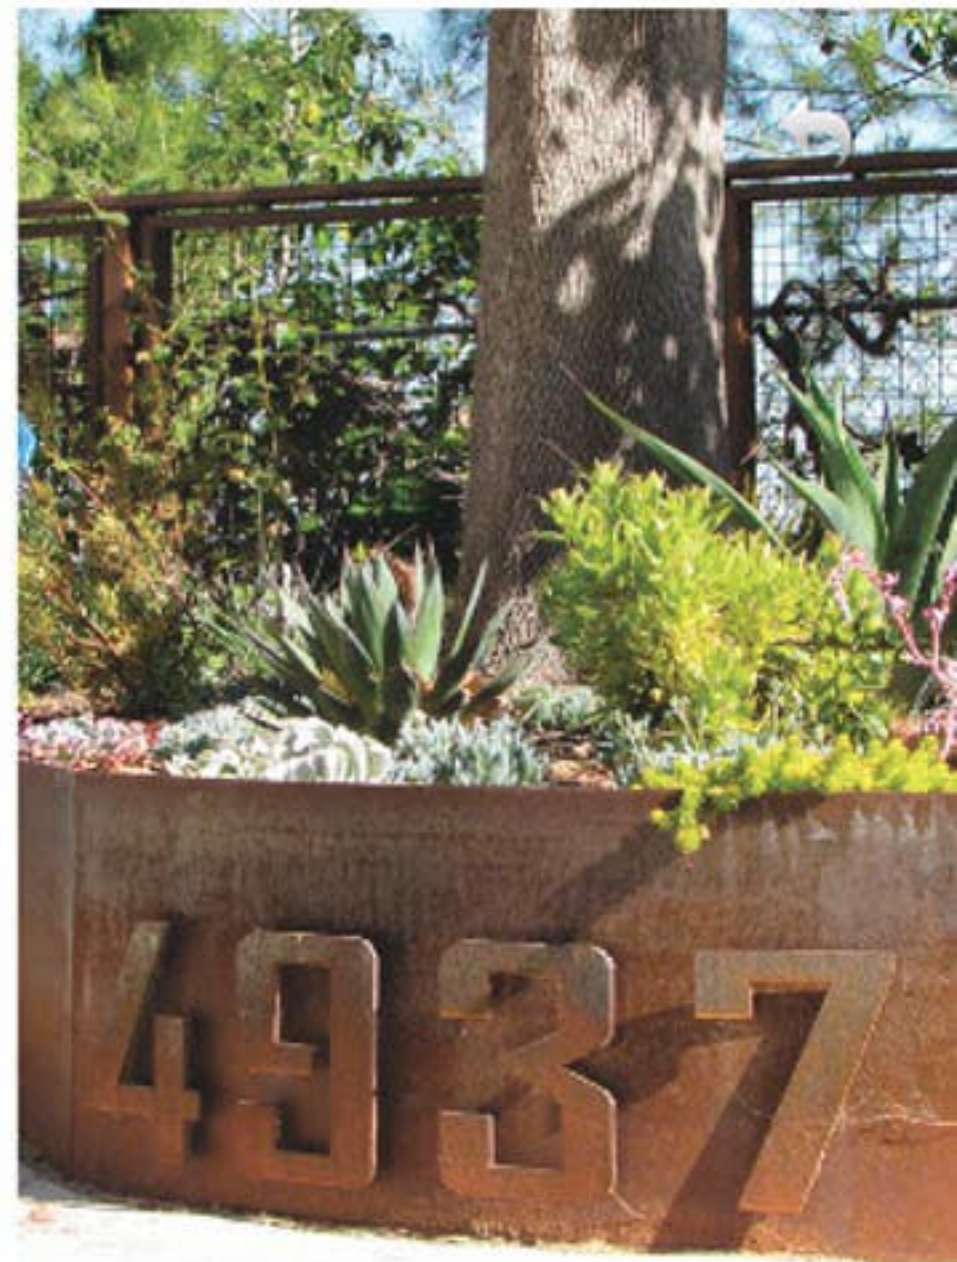
The numbers that were cut out were then applied to this COR-TEN raised planter bed at the entrance of the same home: another good example of how imagination and innovation can come from fencing projects.

David O. Lightfoot of David Lightfoot Landscapes, designed and built the fence behind the planter box. It was designed as a swimming pool security fence that would be pleasing to the eye and not block the view from the property. The redwood frame was made with 4" x 6" posts and 2" x 6" caps. The fence has 5' x 5' panels with 1-1/2" square steel mesh fastened to the back of mitered 2' x 4' redwood frames. The wood has a semi-transparent finish, while the metal mesh was left unfinished.

A concrete continuous grade beam was poured with steel (Simpson PB) post bases set in. The 4' x 6' posts were mounted and the 2" x 6" caps were fastened to run continuously. The 5' x 5' panels were fabricated on site and suspended in each frame with uniform spacing (long construction screws and cylindrical spacers). The finish was applied after construction.
